THE SOUTHWEST PAVILION OF ANGKOR VAT TEMPLE: DAMAGE ENCOUNTERED AND CONSERVATION EFFORTS

Hans Leisen, Esther von Plehwe-Leisen¹, Long Nary², Simon Warrack³
Dana Krause, Johannes Kroner, Christine Schmalz⁴
German APSARA Conservation Project (GACP)

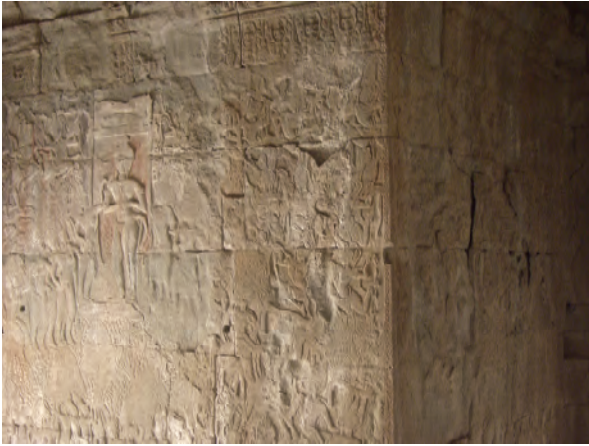
Angkor Vat temple is built from an argillaceous sandstone with a medium high capillary water uptake (Leisen et al. 1996, 1998). One most characteristic degradation phenomenon of this stone is contour scaling with scales of two or three centimetres thickness carrying the reliefs. In the Southwest Pavilion they appear specifically in the higher portions of the walls where high salt contents are existent due to rain water impact, soluble salts from bat droppings and wash off from cement mortars. After the scales are fallen off and the precious reliefs are lost, a brittle zone with flaking and total structural decomposition is revealed (Figure 4). On the Pavilion walls there are considerable areas of scales threatened by loss.

Figure 4: Thick scales are typical decay phenomena with the Angkor Vat sandstone.

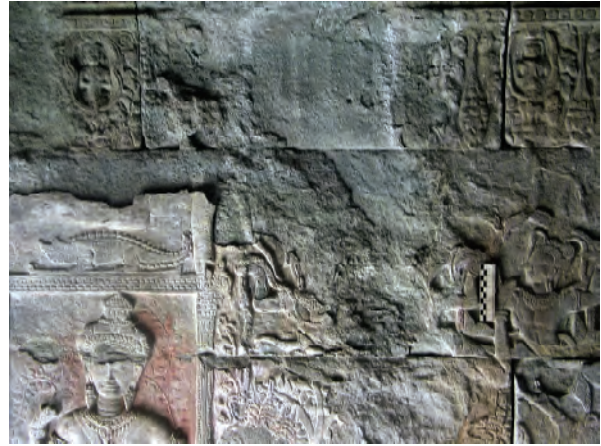
But we also see a different type of scale, atypical for Angkor Vat's building stone. These very thin scales measure only 3 millimetres thick (Figure 5). The appearance of very thin scales is a typical result of ill-adapted impregnation treatment, carried out with insufficient intrusion depth and using agents with a vapour permeability. Coatings of this type can be identified all over Angkor Vat temple by the glossy and sometimes whitish appearance of the walls. The widespread distribution of this damage form in the Southwest Pavilion became manifest through a detailed mapping of all reliefs at the beginning of conservation activities.

Figure 5: Thin scales are a common damage feature in the Southwest Pavilion.

The surface areas of the stone blocks are most subject to climatic changes. Therefore abrupt changes in stone properties near the stone surface are known to lead to subsequent damage. So the acrylic layers on the pavilion walls may be explained as catalyzers for the formation of the thin scales endangering the decorated surfaces.

Considering the medium water uptake of Angkor Vat sandstone, an intrusion depth of 2-3 cm is required for consolidation agents and water repellents (Snethlage 1997, WTA in prep.). Impregnation tests with MMA solution showed an intrusion depth of 3-4 mm only (Albers 2000). It is here that the detaching zone of thin scales is developed in the Pavilion, clearly demonstrating the risk of damage after treatment with insufficient intrusion depth.

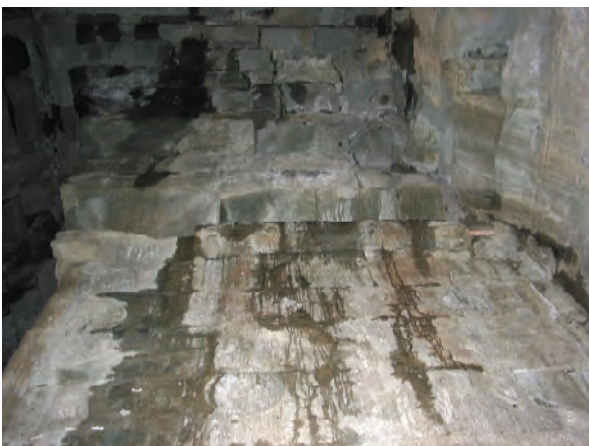
Water intrusion is ubiquitous in the pavilion. Rain water enters the building by open joints and leaking roofs, even though all joints have been closed with cement mortar during former restoration interventions (Figure 6).

Figure 6: Water infiltration from open joints and leaking roofs is a very serious damaging factor.

Decay mappings at the Southwest Pavilion revealed that large portions of cement-based pointings and washes are partly detached from the substrate. The joints closed by cement mortars are open again and let rainwater intrude into the Pavilion. It is even possible to see the sky through some of them. During the former intervention joint mortars in the upper regions of the walls were only applied superficially, not as

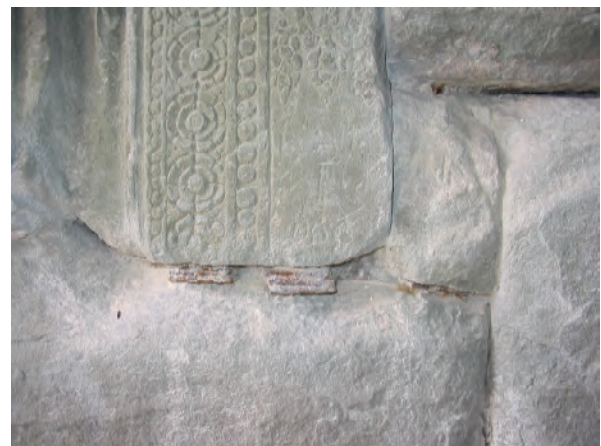
In the base areas salt accumulations are quite visible. Due to the damaging effect of the salts considerable parts of the decorated surface are already lost in this zone. Salt margins also line the cement stone repair mortars applied all over the pavilion walls during the former restoration phase. The original stone substance of the margins is not only affected by salt deterioration but also by the influence of the very hard and dense cement repair mortars themselves. Metal plates introduced into the walls for stabilisation are rusting and bursting the surrounding stone blocks (Figure 7).

Figure 7: Rusting iron jacks from former restoration affect the original stone by bursting.

After removal of big cement parts in the base areas, rusting iron bars appeared. These are a notable risk factor and must be removed. As they are hidden in the cement mortars, the GACP conservation team was supported by the CMAC demining team in locating the invisible metal bars with metal detectors.

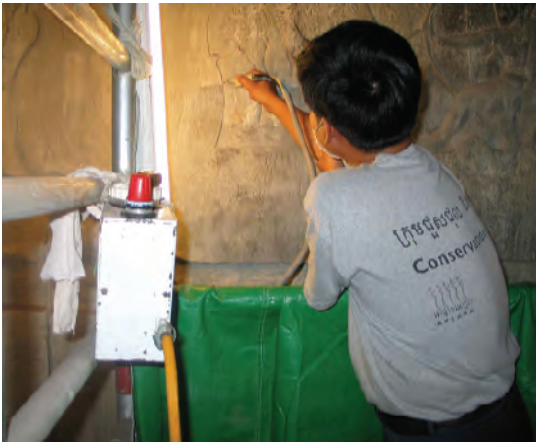
High salt contents are widespread in the pavilion. They are visible in the upper walls and the vaults, on the floor and in the base areas of the walls, around the margins of the cement pointings, washes and joint mortars. In addition to gypsum, nitrates and chlorides make up a large portion of the soluble salt content. Phosphates are also present to a considerable degree. In the Southwest Pavilion contamination with soluble salts normally surpasses 1 wt.% of the stone surface. This large quantity of soluble salts requires a salt reduction measure (WTA 2003). In addition to their immediate damaging effect, large quantities of salts also render conservation measures like pointing and washes less sustainable and make necessary steps, such as consolidation impregnation, harmful to the stone blocks.

Figure 8: Thick salt layers have to be thinned out before they are reduced by water poultices.

The most effective method of salt reduction on walls is desalination by poultice application. A wet poultice made from clay and cellulose fibres is applied to the wall. As a first step the salts have to be dissolved by wetting the wall very thoroughly. Poultices with high soaking abilities on the one hand, and a good capacity to store humidity over a long time period on the other, have to be applied. Salts inside the stone are dissolved, migrate to the drying poultice and are stored there. In this way they can be removed together with the dried poultice. The salt reducing effect is influenced by the chemical nature of the salts present, by the soaking properties and the drying velocity of the poultice and by climatic conditions. Test areas with different poultices and varying drying times were carried out in order to determine the most effective materials and parameters for the measure. Analysing the qualitative and quantitative salt contents in the poultice serves as quality control for the desalination procedure. The process of salt reduction was repeated up to two times before obtaining satisfying results.

Preceding the poultice treatment thick salt crusts were thinned out by small particle blasting

equipment with low pressure (Figure 8). The particles mixed with salts were properly collected and disposed of before the salts could re-enter the pore space of the stones.

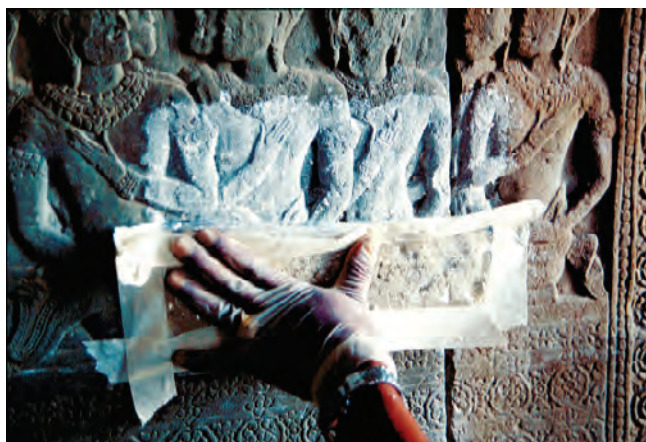
Figure 9: After the removal of the poultice the underlying wall has to be washed with solvent.

Stone samples were coated with MMA and removal experiments were carried out in the laboratory in order to identify the best combinations of solvent and poultice (Albers 2000). These were then applied at test areas at Angkor Wat (Figure 9). Covering the poultices prevents fast evaporation of the solvent and prolongs the reaction time. The success of removals was controlled through tests of water uptake and air permeability (Figure 10).

In a very time consuming activity, patches of 20 x 20 cm were covered with poultice materials for one hour, after which the poultice was taken off and the area washed with acetone. The whole process was repeated twice. In this manner all inside walls were treated from top to bottom (Figure 11). Fans were installed to provide ventilation and to limit release into the air of harmful substances from the solvents.

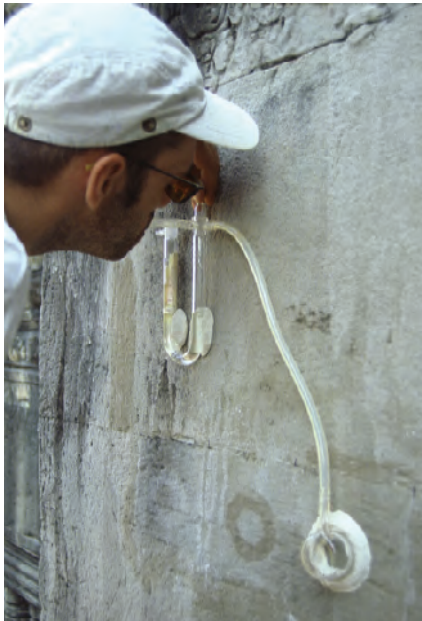
Figure 10: Tests of air permeability help to determine the success of the removal.

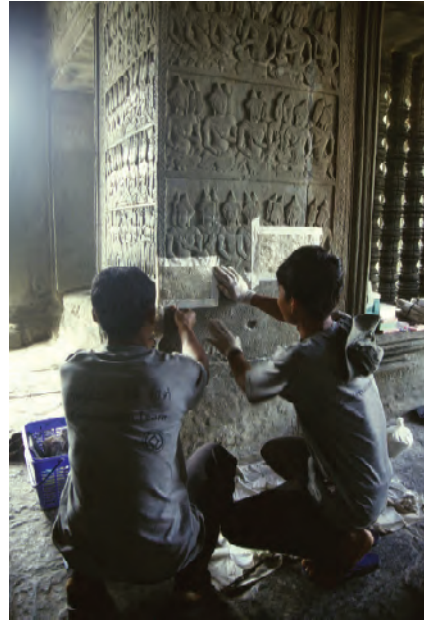
Figure 11: Step by step, small areas are cleaned of acrylic resin.

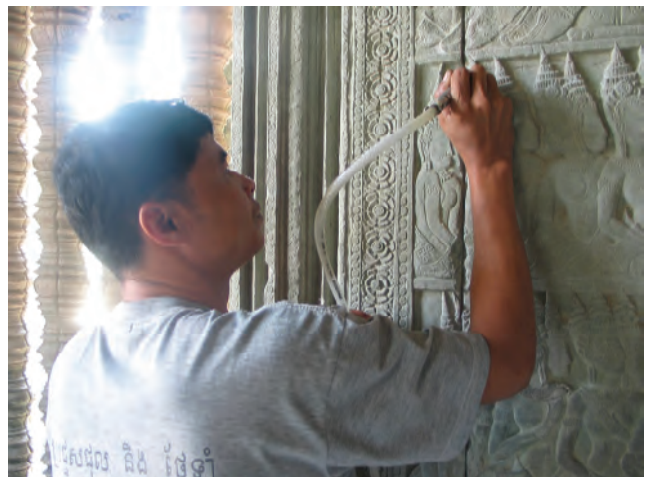
Figure 12: Like a dentist the conservator takes off the cement parts from the precious reliefs.

Removal of the cement mortar is a very delicate task if reliefs are not to be damaged. The thin cement-based washes and pointings require particular skill and micro-tools to take off. The conservators of the GACP team have considerable experience with careful removal of cement mortars. Vibrating micro-chisels serve well for taking off thin layers from sensitive surfaces (Figure 12). To open big joints full of mortar bigger chisels are used. No big electric equipment is employed.

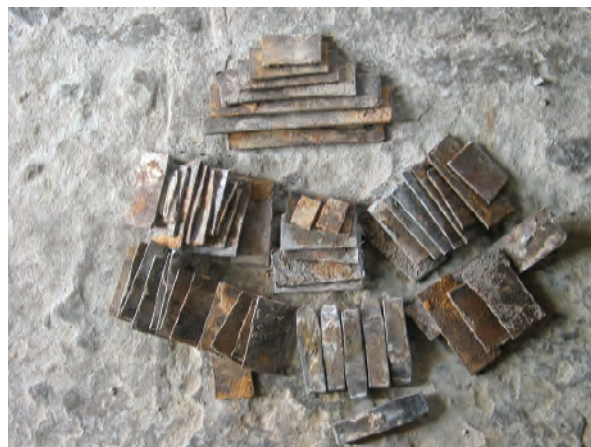
Figure 15: The "crop" of iron jacks from two weeks' work.

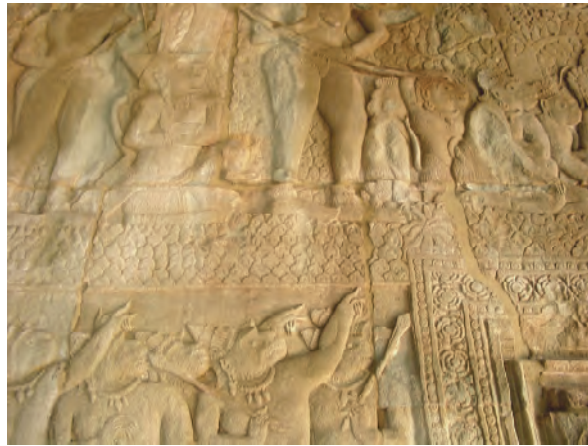
Figure 17: Joints after closing with adapted mortar.

Up to this point, all conservation measures had been applied to the interior of the Southwest Pavilion. The first step performed was the removal of the cement repairs. The cement mortars were taken out of the joints. Then acrylic coatings were stripped, followed by salt reduction. Joints were filled with mortars specially adapted to the needs of the Angkor Vat sandstone. The iron bars were removed (Figure 15). Special mortars developed in order to match the stone properties were used to close the open joints. Very broad joints were first filled with stone pieces, before the mortars were pressed into the joints.
