# THE EAST AND SOUTH ENTRY TOWERS OF CHAU SAY TEVODA RESTORATION DESIGN DESCRIPTION

*Chinese Government Team for Safeguarding Angkor*

## Section One: Restoration Design of the East Entry Tower

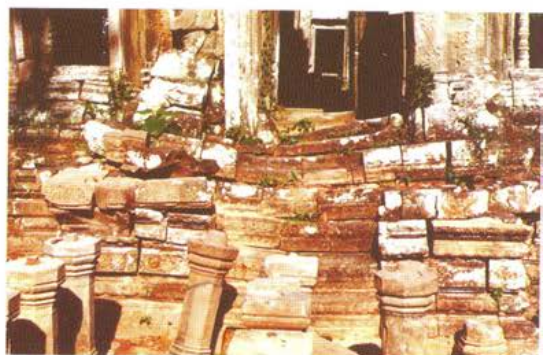
Figure 2. Eastern Entrance Platform of East Entry Tower.

Most of the masonry stones of the platform have been dislocated, especially those of the east porch and the south passageway. The platform itself has subsided, with the masonry becoming loose and deformed, and components falling off. (Figure 2).

We aim to place those seriously subsided and dislocated stone blocks back in their original positions, to reinstate missing elements and destroyed components and to ensure proper drainage and seepage prevention.

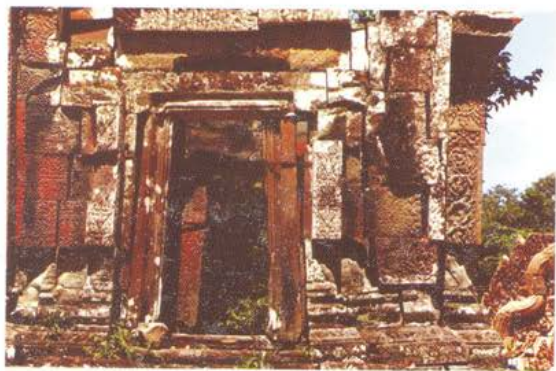
Figure 3. West Entry of South Passageway of East Entry Tower.

The whole south passageway is tilting to the southeast. The pediments and roof arch stones over the east and west entries have collapsed, the door stone has subsided and caused the doorframe to tilt inward (Figure 3).

To repair the east walls, the west walls and the gable, and to correct deformation of the building.

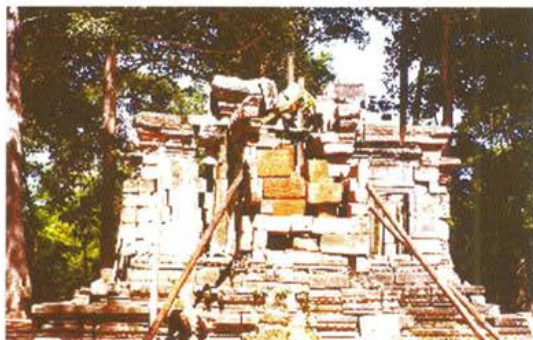
Figure 6. South Entry Tower.

Analysis of the existing structure, in conjunction with matching and reassembling collapsed components, allows us to hypothesize that before collapse the South Entry Tower consisted in a vault built over the porch; the roof of side rooms were stepped; and each had sets of pediments (Figure 6).

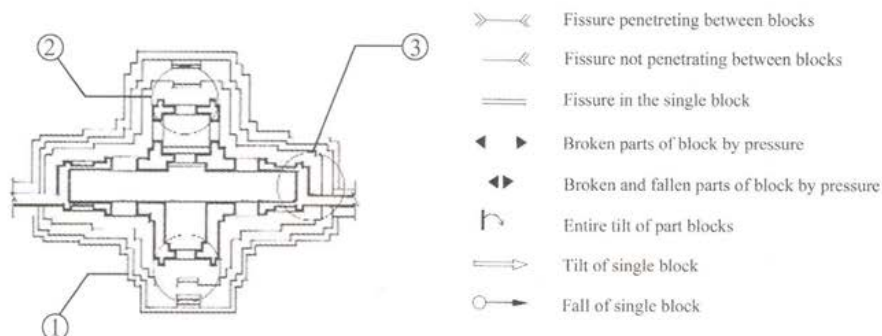
Figure 4. Damage to South Entry Tower

The South Entry Tower is seriously damaged. With the exception of the platform that is still relatively complete, most of the roofs have collapsed, leaving only broken walls. The vault of the central hall and the roof of the north entry porch have collapsed. The remaining walls of the east and west side rooms and of the south entry are also seriously tilted and deformed: the south wall of the east side room is tilting inward by 17cm; the west wall of the south entry is tilting eastward by 15cm. The doorframe, lintel and pilasters, etc. at the south entry have therefore broken, cracked or collapsed. A vertical crack of 10 ~ 16cm in width appears at the southeast corner of the central hall.

First, we have a problem of building structure. The foundation of the main structure above the base is a strip foundation. However, the main structure was built by simply piling up stone blocks. No bonding agent was used and the piling of the stone blocks was irregular, in stark contrast to traditional Chinese construction methods of staggered-joint bond. For this reason, the integrity of the building is poor, causing the foundation's upper load to be unevenly distributed. The platform composed of sand and soil, and laterite and sandstone blocks shoulders the upper load. However, the gradation of the sand and soil fill inside the tower base is poor, its relative density being low. A field test showed the bearing capacity to be only between 0.1~0.3Mpa. As a result, the stability and balance of the building depend only on the weight of stones and the frictional force between stones, contending with lateral pressure produced by the main building load. Therefore, the insufficient strength of certain parts of the base has decidedly contributed to the uneven subsidence of the building itself.

The second major cause of deterioration is nature. Tropical rain forest areas are characterized by large woody plants and insects which reproduce rapidly. The effects that tree root cleavage, biological activity, rainfall and strong winds have on buildings are obvious. Long-term effects of these on the building structure and the density of the foundation are disastrous.

The roofing and most walls of the South Entry Tower have collapsed. Those remaining walls and porches are themselves tilted and deformed and could collapse any minute. For this reason, restoration work on the South Entry Tower should include "Emergency Protection and Consolidation" as well as "Restoration with Priorities." Those seriously deformed structures should be dismantled and rebuilt. These include damaged walls of the east wing and the west wing, the porch of the south entry and the southwest corner area of the platform, etc.

Restoration priority is given to the following: walls below eaves, windows, platform, and roofs of the east and west wings and pediments of the central hall. So far, more than a hundred components fallen from walls, blocked up windows, eaves etc. have been discovered. After restoration, not only should the South Entry Tower no longer be in danger, but it should appear better intact, with the fallen components back in their original positions. We estimate that, with the exception of the vault of the central hall and the roof of the south and the north entry porches, the structure could be restored to varying degrees.
