THE SOUTHWEST PAVILION OF ANGKOR VAT TEMPLE: DAMAGE ENCOUNTERED AND CONSERVATION EFFORTS

Hans Leisen, Esther von Plehwe-Leisen¹, Long Nary², Simon Warrack³
Dana Krause, Johannes Kroner, Christine Schmalz⁴
German APSARA Conservation Project (GACP)

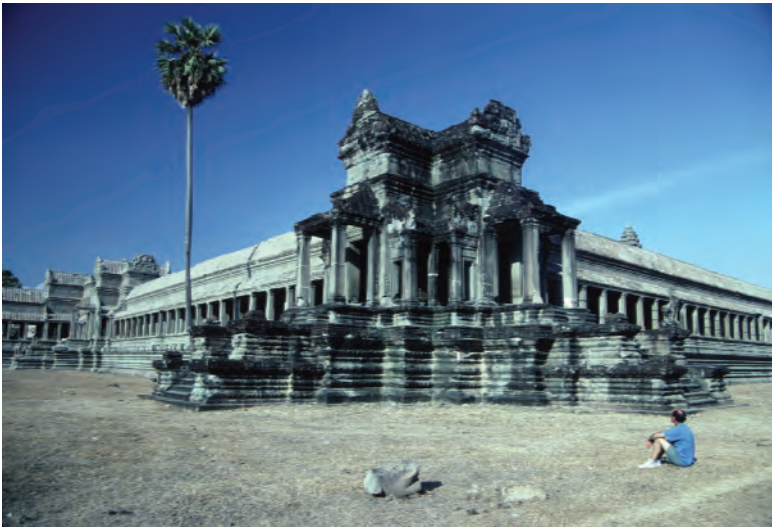
Figure 2: View of the Southwest Pavilion in 1995.

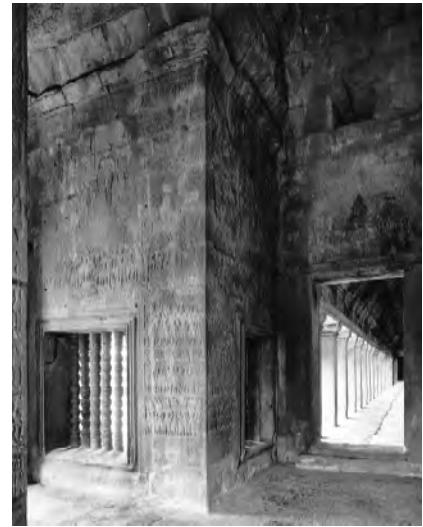
The Southwest Pavilion is located at one corner of the western galleries of the third enclosure. Long periods of water intrusion, bat colonisation, anastylis and other earlier restoration interventions have caused a multitude of different damages that highly endanger the reliefs.

Figure 3: The Southwest Pavilion walls are decorated with precious reliefs.

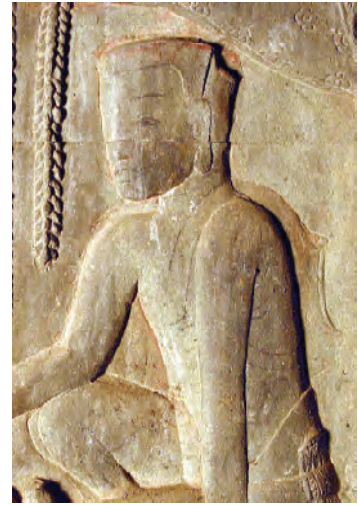
Figure 13: Traces of line drawings and polychromy survived long periods of neglect and invasive restoration interventions.

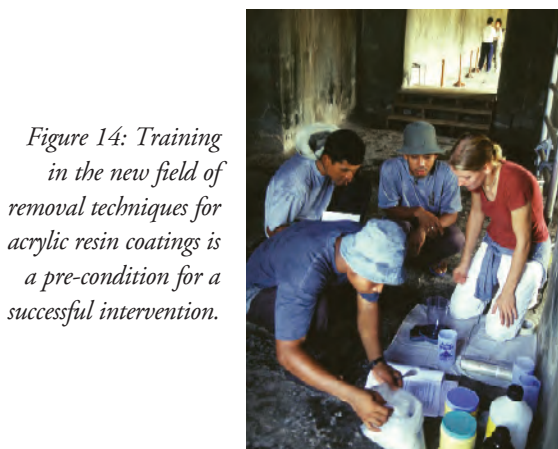
Figure 14: Training in the new field of removal techniques for acrylic resin coatings is a pre-condition for a successful intervention.

Another most important task was to lead the GACP team to a new field of activity. Removal of the acrylic layers provided new scope to the team's work. The tested and optimised procedures were taught and after a short initial period the Cambodian conservators became specialists in that matter (Figure 14). A small "Handbook of Removal of Acrylic Layers" was compiled in English and Khmer to guide all aspects of practical execution of further conservation interventions.

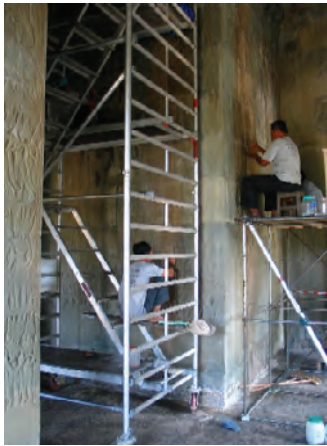
Figure 16: Team members executing the final conservation operation.

Now the GACP conservators can continue with their usual every-day conservation tasks like consolidating fragile parts of the walls, re-attaching the loose scales and closing holes and edges (Figures 16 and 17). There is still a good deal of work to do! We must not forget that joints have to be closed from the exterior, too.
